**GEOLOGIC CROSS-SECTION  
(DIAGRAMMATIC)**

**NICKLE PLATE MINE  
PA DEP, BAMR  
MCDONALD SOUTH - OSM 63(1441)101.1**

McDonald Borough & North Fayette and Robinson Townships  
Allegheny and Washington Counties, Pennsylvania  
Scale: Varies June 30, 2005  
**Environmentally Innovative Solutions, LLC**  
Pittsburgh, PA

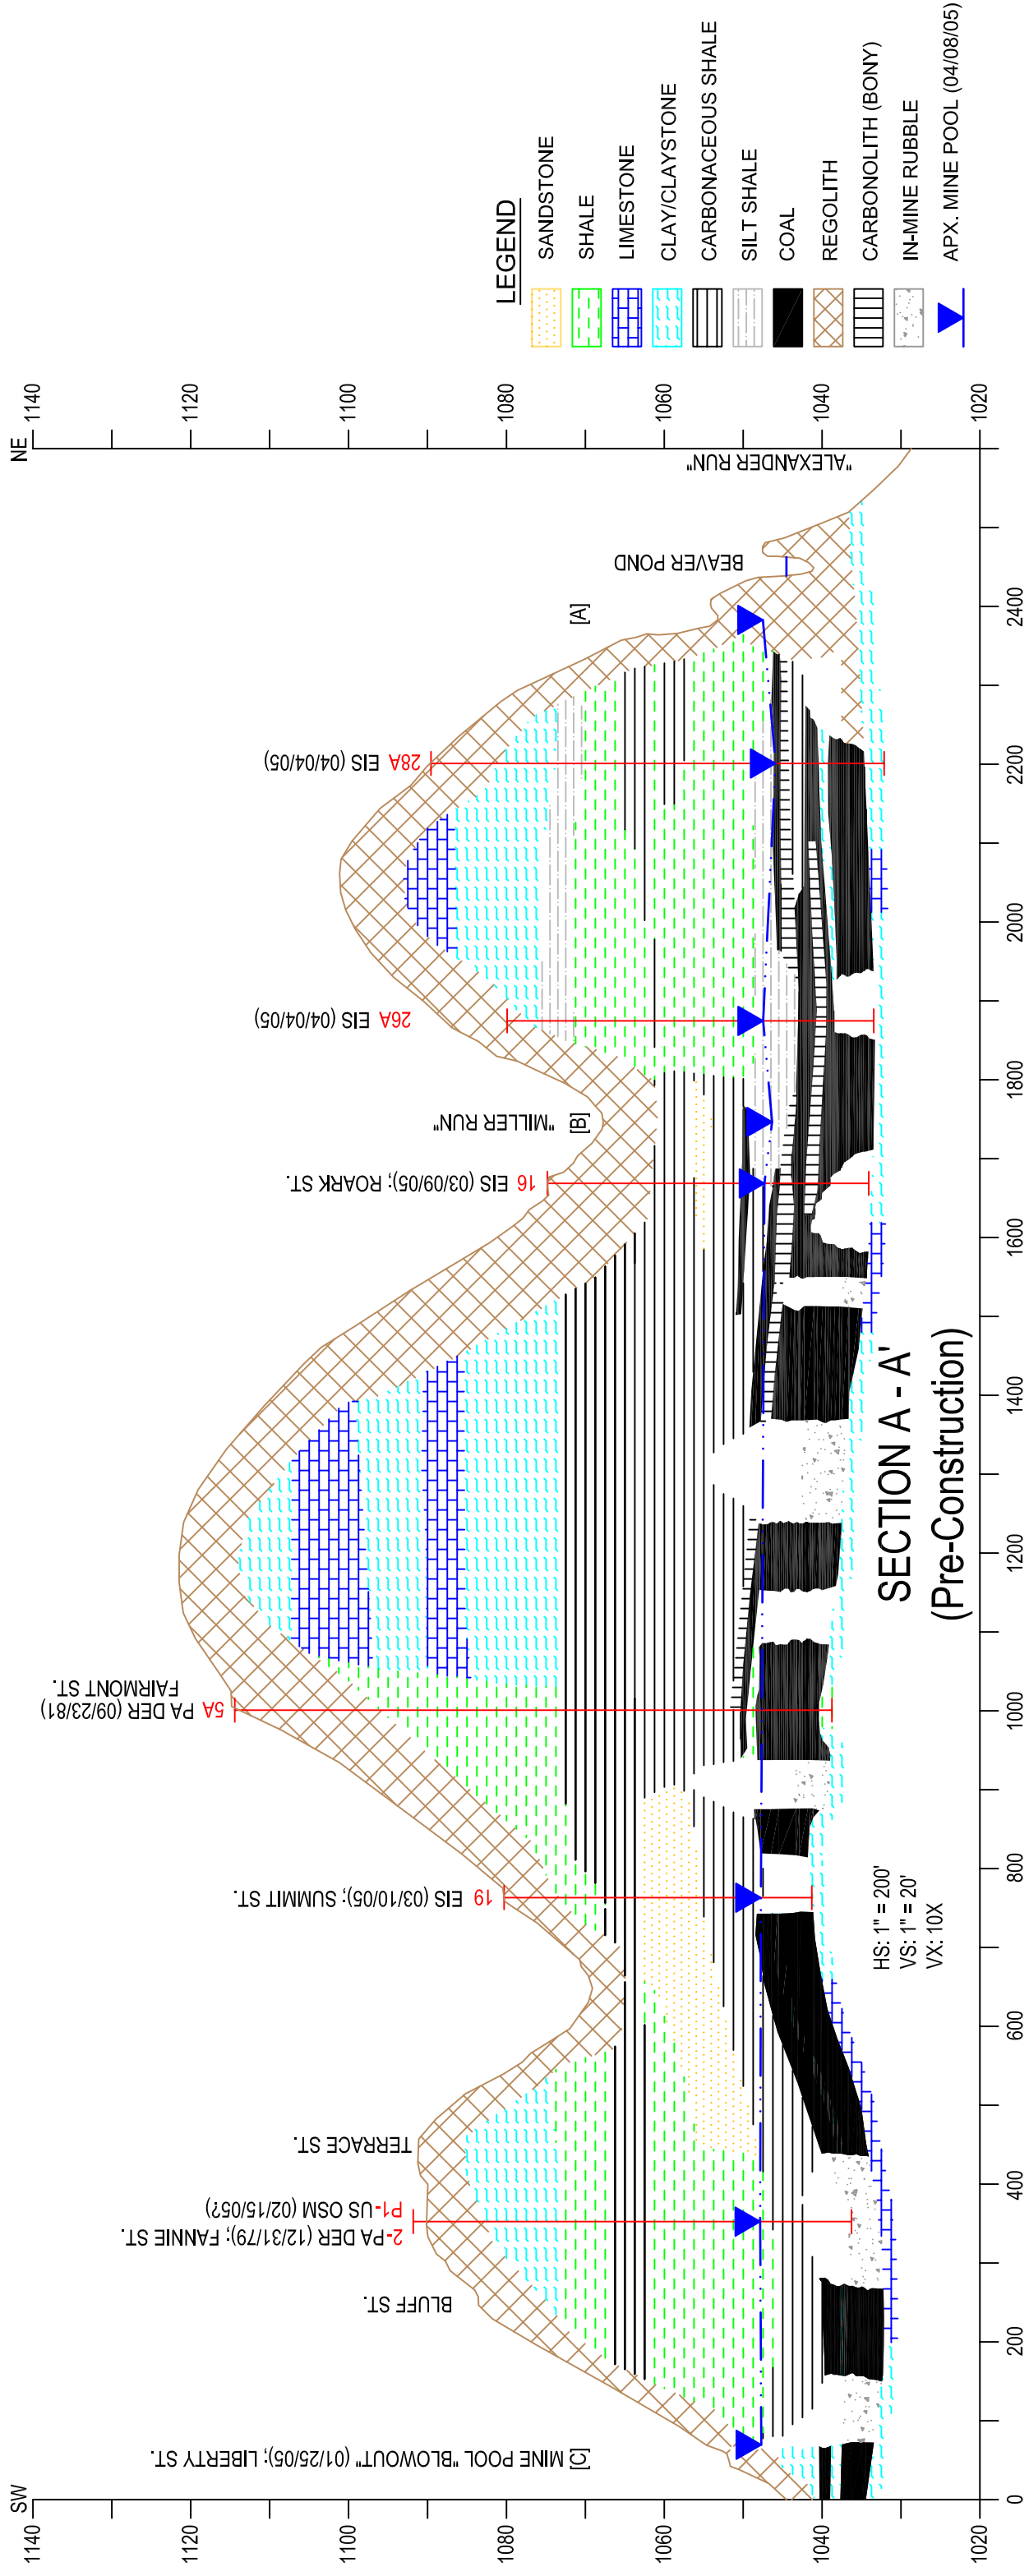
- MAIN ENTRY OF NICKLE PLATE MINE LOCATED ABOUT 350 FEET SOUTH OF DRILL HOLE 19 AT AN ELEVATION OF 1035 FEET.
- STANDING WATER LEVELS SHOWN WERE MEASURED 04/08/05 AFTER EXCAVATION OF TEST PIT 1 FOR PRIMARY DRAIN AND TEST PIT 3 FOR SECONDARY DRAIN PRIOR TO DISCHARGING AT PRIMARY DRAIN.

- [A] PRIMARY DRAIN INSTALLED BY EXCAVATING A SUBSIDENCE DEPRESSION (TEST PIT 1) IN VICINITY OF ENTRY. TRASH, WOODY DEBRIS, AND "SPOIL-TYPE" MATERIAL REMOVED. COLLECTION AND CONVEYANCE SYSTEM INSTALLED 05/09/05.

- [B] SECONDARY DRAIN INSTALLED ABOUT 200 FEET SOUTHEAST OF DRILL HOLE 16 BY EXCAVATING A SUBSIDENCE DEPRESSION (TEST PIT 3) LOCATED ABOVE HAULAGEWAY OR ROOM. CAVED MATERIAL EXCAVATED AND COLLECTION AND CONVEYANCE SYSTEM INSTALLED 05/09/05.

- [C] EARLY WARNING SYSTEM INSTALLED COLLECTION SYSTEM AND RISER IN "BLOWOUT" AND REPLACED PUBLIC SIDEWALK 05/09/05.
- SEE "AS-BUILTS" OF PRIMARY DRAIN, SECONDARY DRAIN, AND EARLY WARNING SYSTEM.
