CARNEY STREAM BANK RESTORATION PROJECT

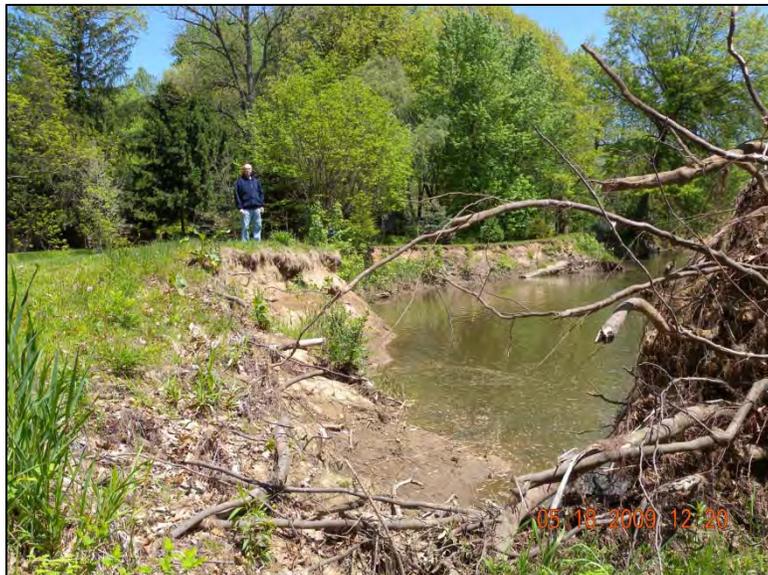
A portion of the severely eroded bank along Slippery Rock Creek. Over 50' of property had been lost eroding over 25,000 cubic feet of soil into the stream.

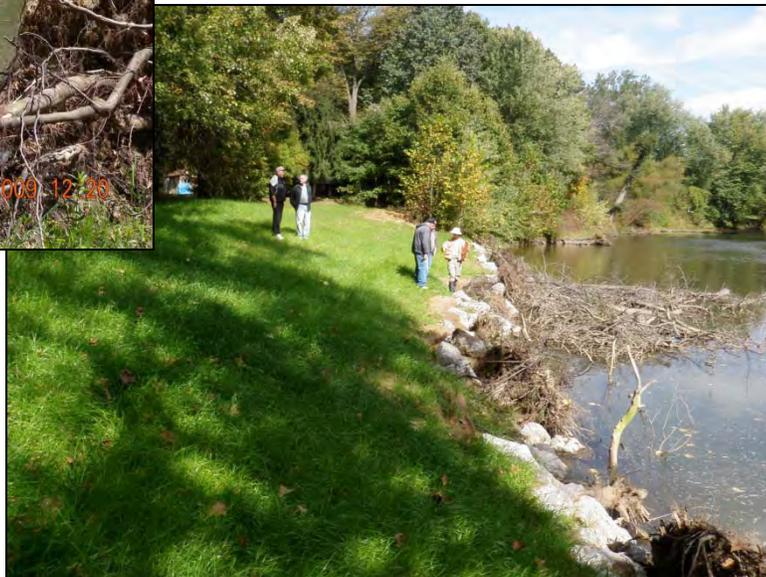
The stream bank looking in the same direction as the before photo approximately 2 months after construction was completed. A tour was given to the Slippery Rock Campground Association located across the stream.

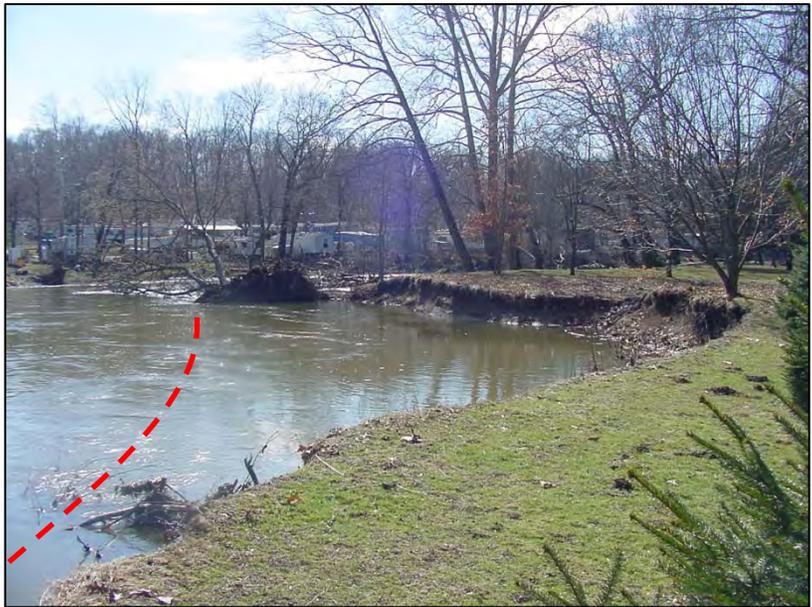
Another photo of the erosion prior to construction. Numerous trees were lost along the stream bank including the large tree seen in the center left of the photo. The red line indicates the approximate original stream bank location.
