GRAHAM PARK STREAM & WETLAND PROJECT

Project Description: This project involved the restoration of approximately 1000 feet of severely eroding stream bank along Brush Creek. A combination of traditional and bioengineering techniques were used to reinforce the bank including grading, rootwad revetments, rock vanes, rolled erosion control blankets, and native plantings. Another 500 feet of stream bank was restored with native plantings. A total of over 7,000 shrubs and trees were planted along the streams. In addition, a 1.35 acre wetland was constructed and planted for mitigation of impacts from the construction of the park complex. Over 50,000 trees, shrubs, and herbaceous plants were placed within the wetland. BioMost, Inc. provided planting and construction oversight services for this project.

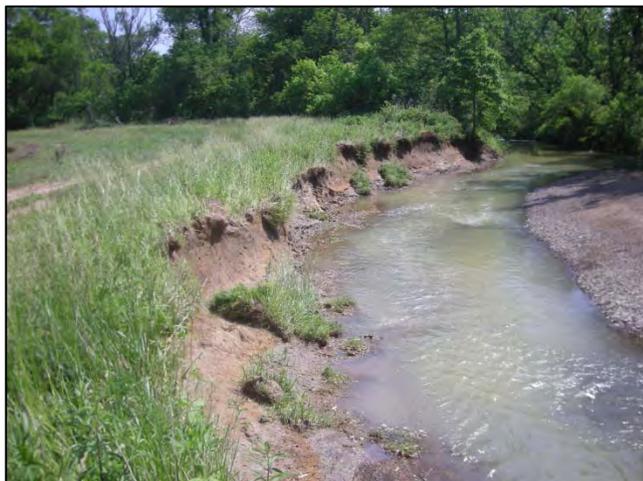
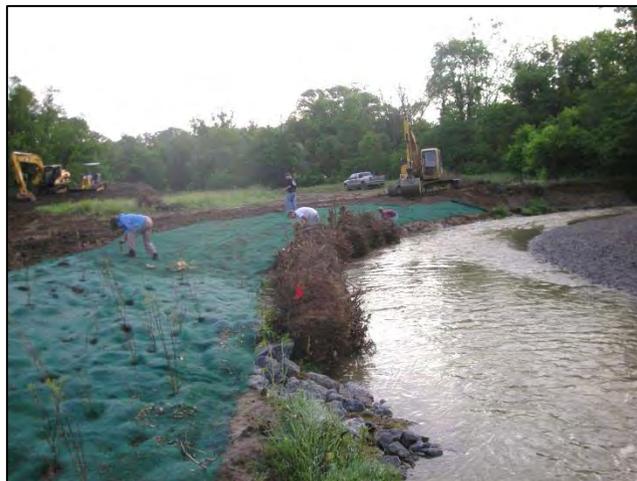
Above: A portion of the severely eroded bank along Brush Creek prior to construction. Approximately 1000 feet of stream bank was unstable causing severe erosion during rain events. Flooding occurs frequently within the Brush Creek watershed.

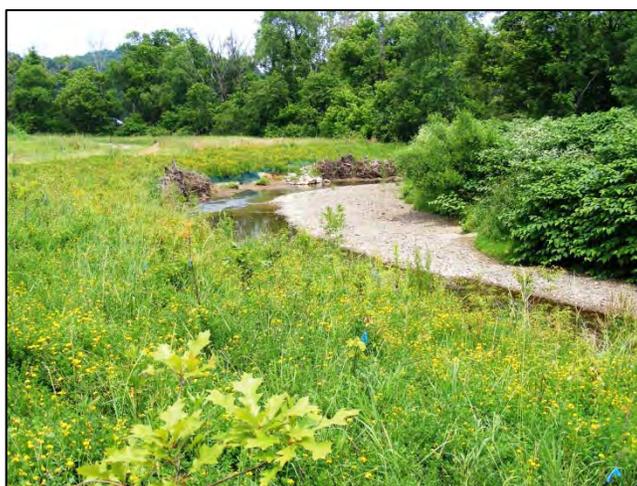
Above: Rootwad revetments, rock vanes, and permanent erosion control blanket were used to stabilize the bank. In addition, over 4100 trees and shrubs were planted along the bank.

Left: One year after construction was completed.

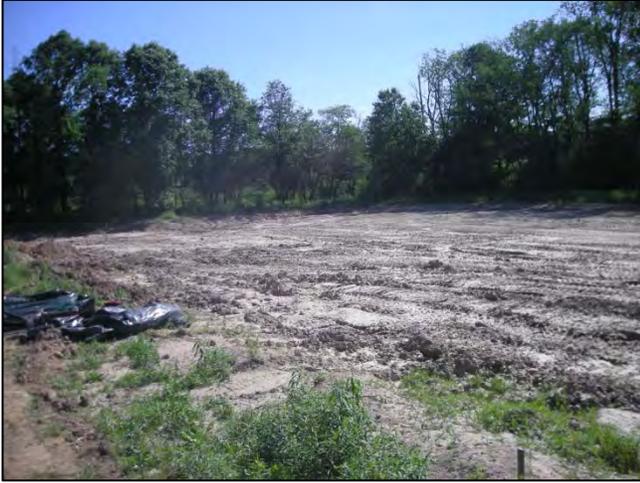
Above: Photo of the wetland prior to final grading.

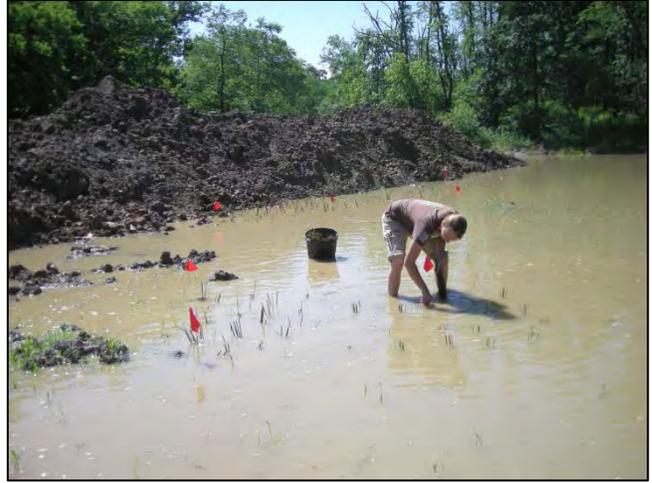
Above: Over 50,000 herbaceous plants and shrubs were planted within the mitigation wetland. Flags were used to delineate areas previously planted.

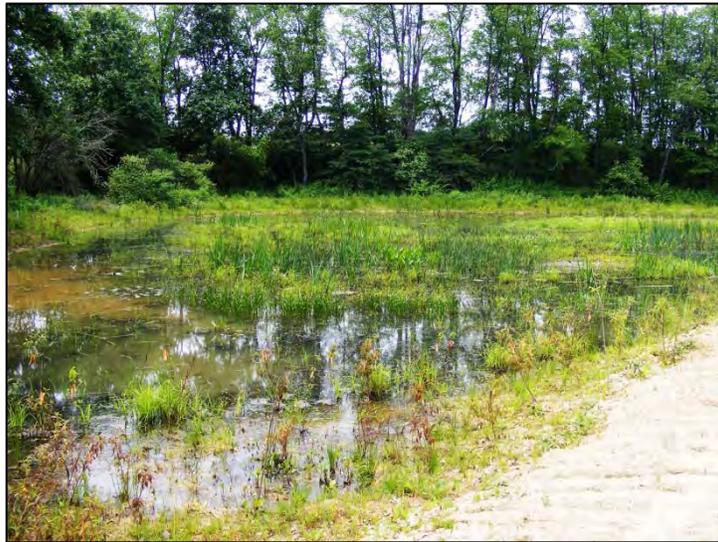
Right: Mitigation wetland one year after construction was completed.

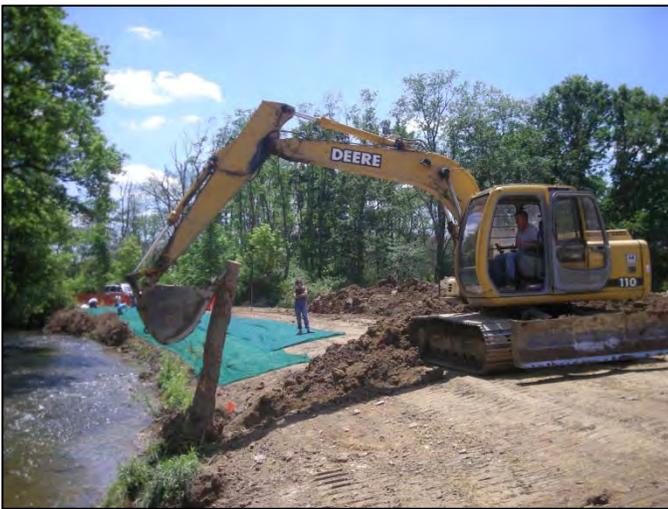
Placement of a rootwad along the bank of Brush Creek.

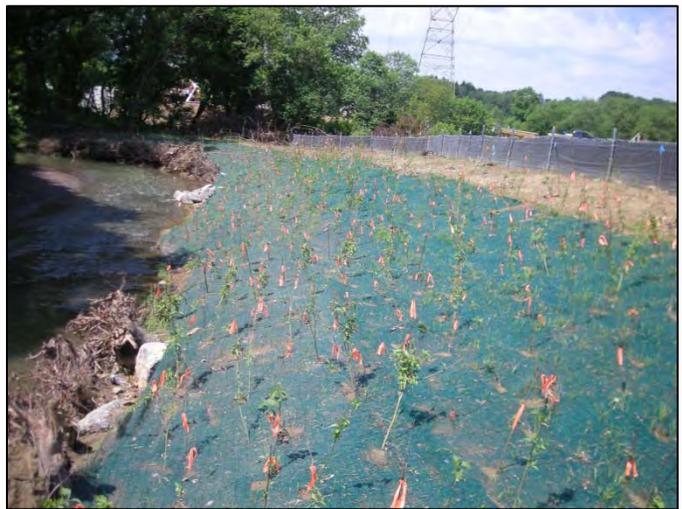
Over 4100 trees and shrubs were planted along Brush Creek. Flagging tape was tied to each plant to assist future monitoring efforts of the designer.
