## Site Investigation and Design Process

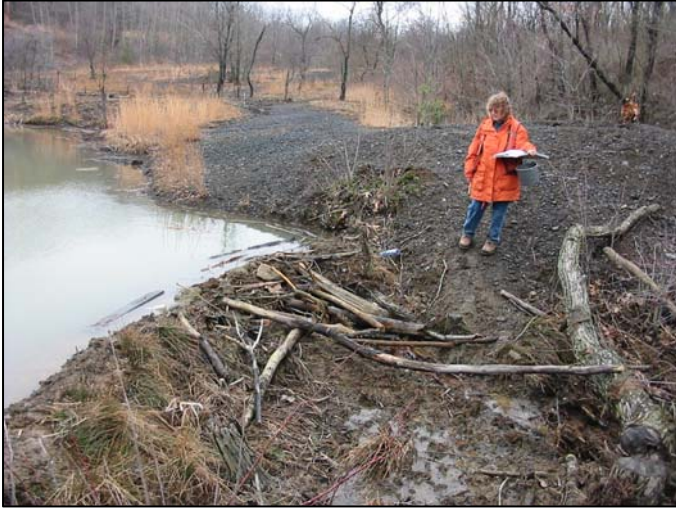
Inspections conducted to determine site conditions. (March 28, 2005)

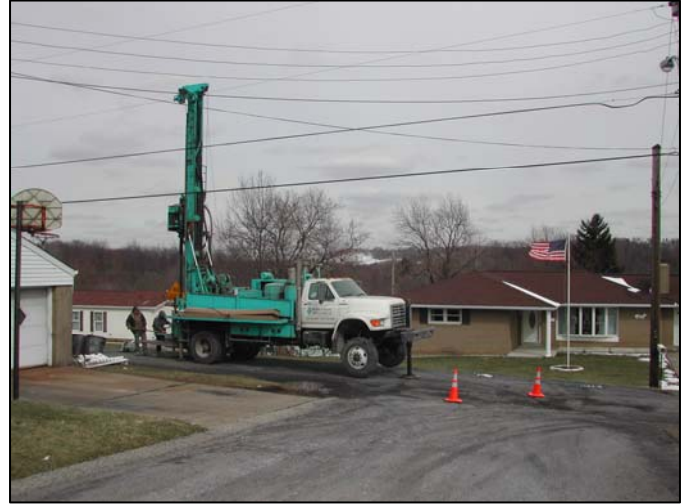
Piezometers installed as part of hydrogeologic investigation. (March 10, 2005 – photo by Rich Beam, BAMR)

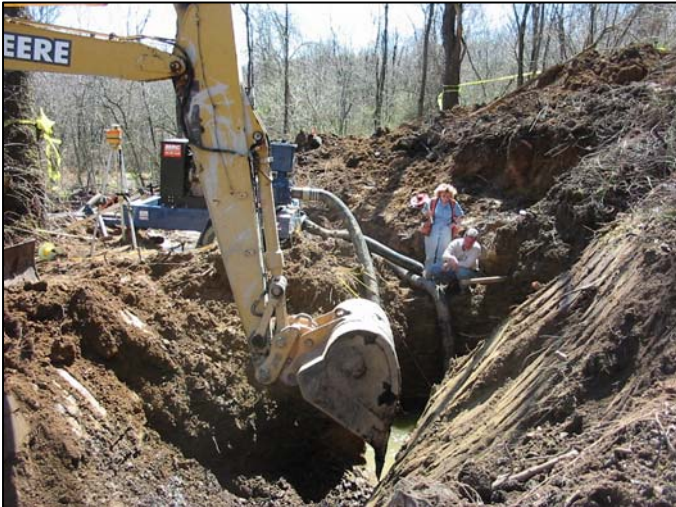
Test pits excavated with pumping conducted to determine favorable locations for Primary and Secondary Drains. (April 8, 2005)

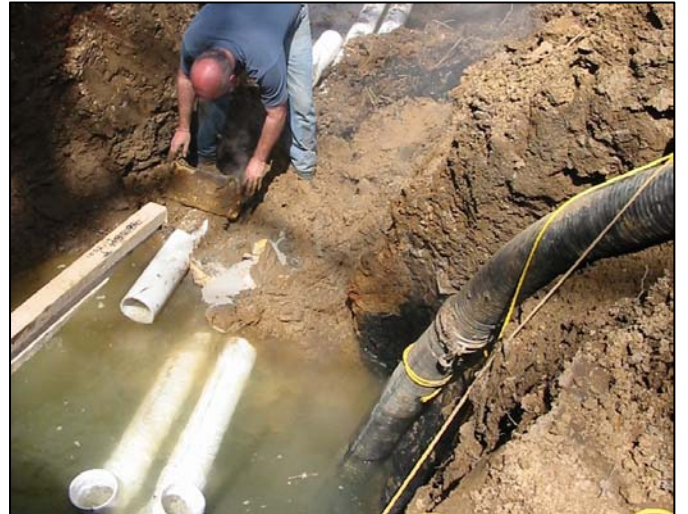
A temporary gravity drain was installed at Test Pit 1 before installation of the permanent Primary Drain. (April 10, 2005)
