Secondary Drain

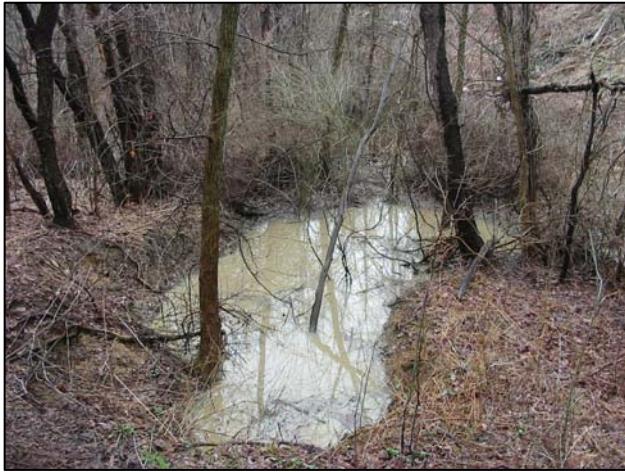
Subsidence depression receiving drainage from "Miller Run" prior to Test Pit 3 excavation. (March 3, 2005)

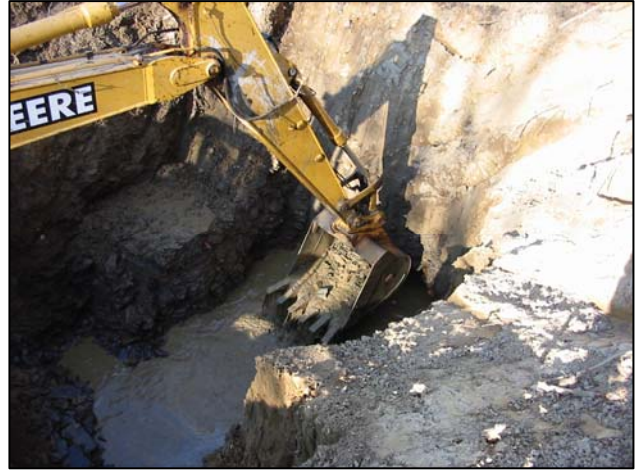
Excavating sump at Test Pit 3 for installation of Secondary Drain riser. (April 13, 2005)

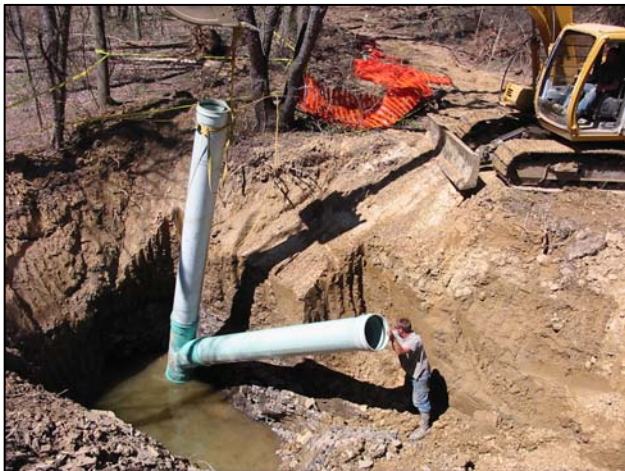
Installation of riser with custom perforations and overflow pipe. (April 13, 2005)

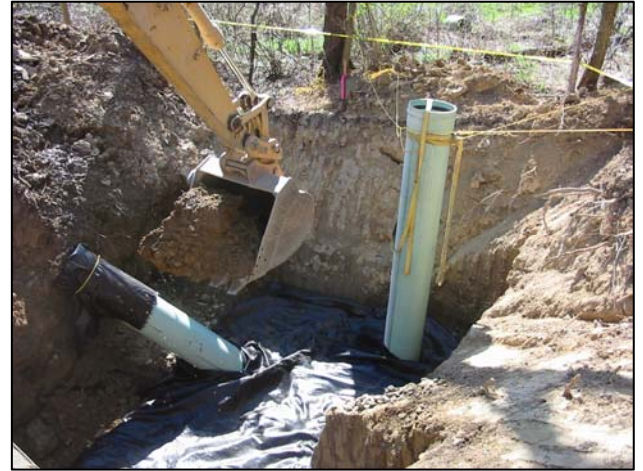
Geotextile used for layer separation of aggregate and backfill material. (April 13, 2005)

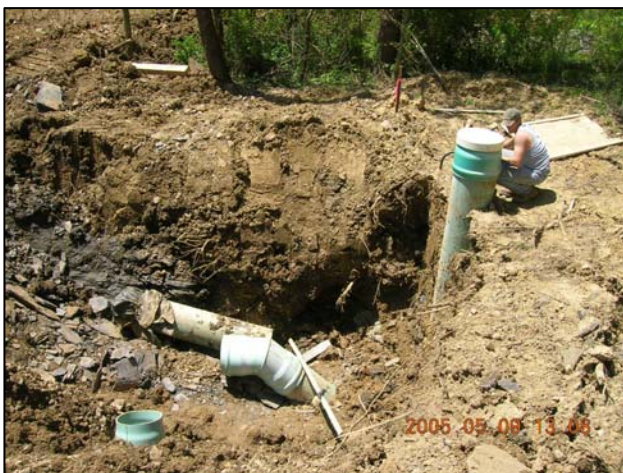
Elbow attached for piping to convey overflow to outlet channel. (May 9, 2005)

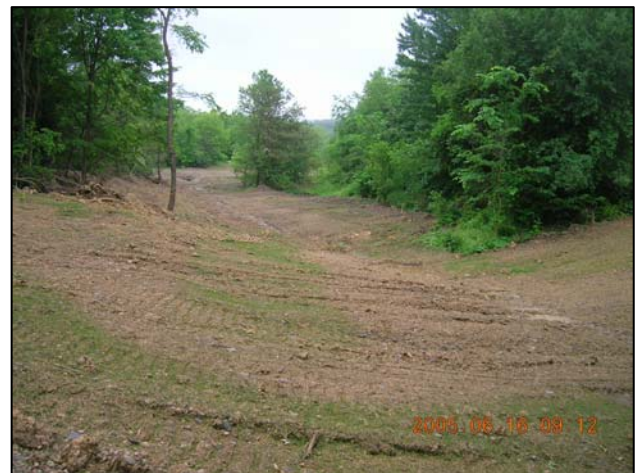
View from Secondary Drain manhole looking down channel towards access road/"Miller Run". (June 16, 2005)
